Manhole Inspection Summary

Manhole # S71E__022MH

Inspection ☐ Is Incomplete Rating: **3) Fair**

Location Address: **Eastbrook**

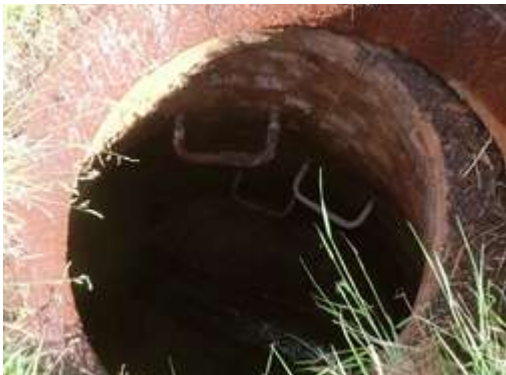
Defect 1

Infiltration: ☐ None ☒ **Joint** ☐ Cracks ☐ Mortar ☐ Roots ☐ Wall

Infiltration

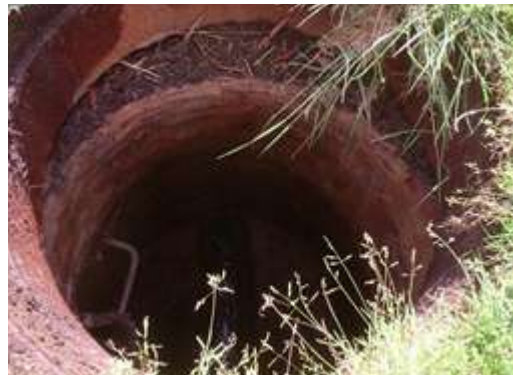
Defect 2

Frame Offset: **5** (in.) Condition: ☐ Sound ☐ Cracked ☒ **Leaks**

Frame leaks

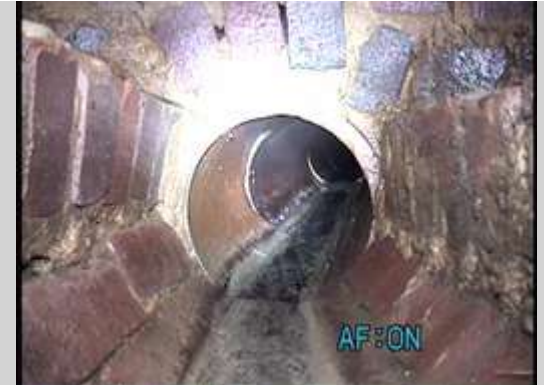
12 O'Clock Outflow

8 in. Circular Gravity Sewer
Pipe Out @ 12 O'Clock

Pipe Height: **8.4** (in.) Rod and Bar (Angled)
Pipe Material: **Clay** ☐ Pipe Lined
Invert Depth: **7.60** (ft.) Flow Characteristics: **Fast**
Deposits: ☒ None ☐ Mud ☐ Sludge ☐ Debris ☐ Grease
Silt Depth: (in.) Deposits Extent:
Infiltration: **None** Pipe Seal Cond: **Sound**

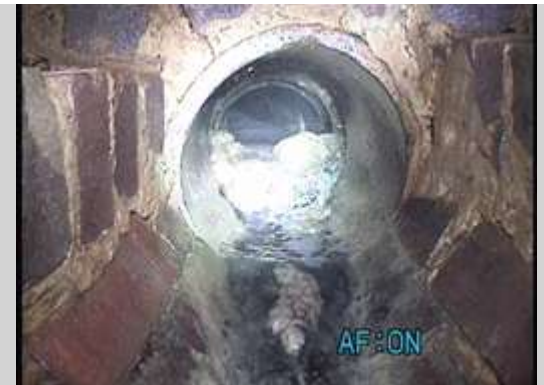
6 O'Clock Inflow

8 in. Circular Gravity Sewer
Pipe In @ 6 O'Clock

Pipe Height: **8.4** (in.) Rod and Bar (Angled)
Pipe Material: **Clay** ☐ Pipe Lined
Invert Depth: **7.30** (ft.) Flow Characteristics: **Fast**
Deposits: ☒ None ☐ Mud ☐ Sludge ☐ Debris ☐ Grease
Silt Depth: (in.) Deposits Extent:
Infiltration: **None** Pipe Seal Cond: **Sound**
